Restoring a Gem

Communication and careful planning and organization pay off.

BY DAVID KUYPERS

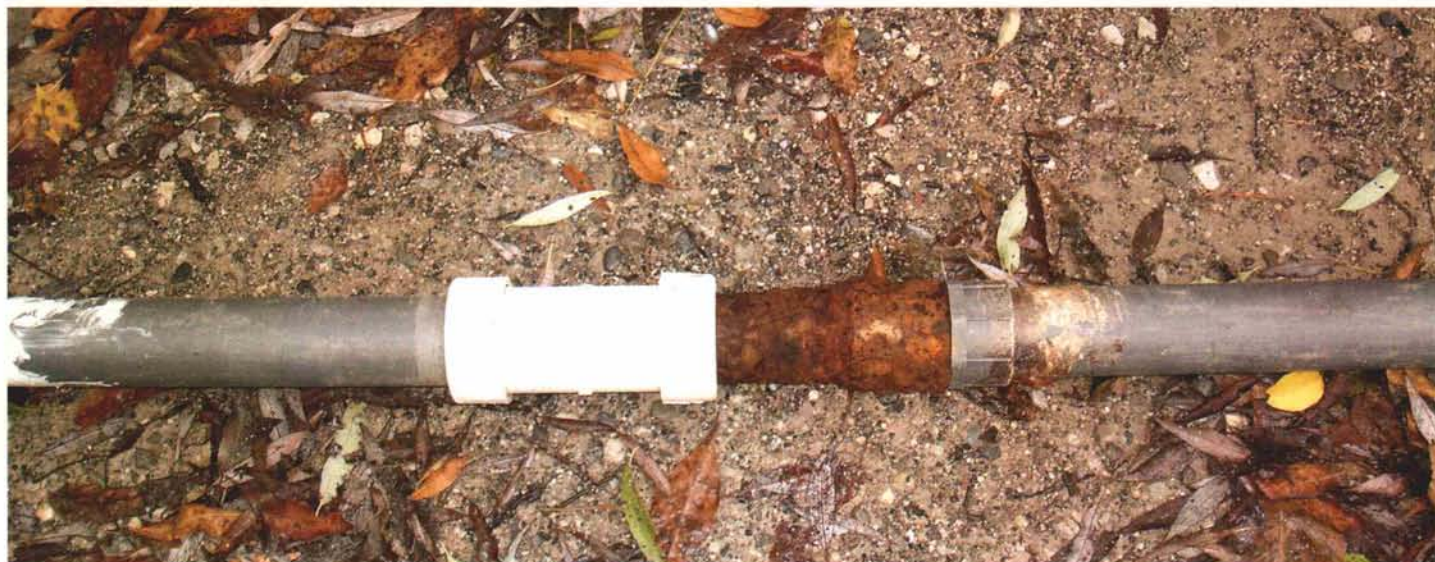
Corroded old pipes were no longer capable of providing adequate hydraulic flow, so coverage and turf performance suffered.

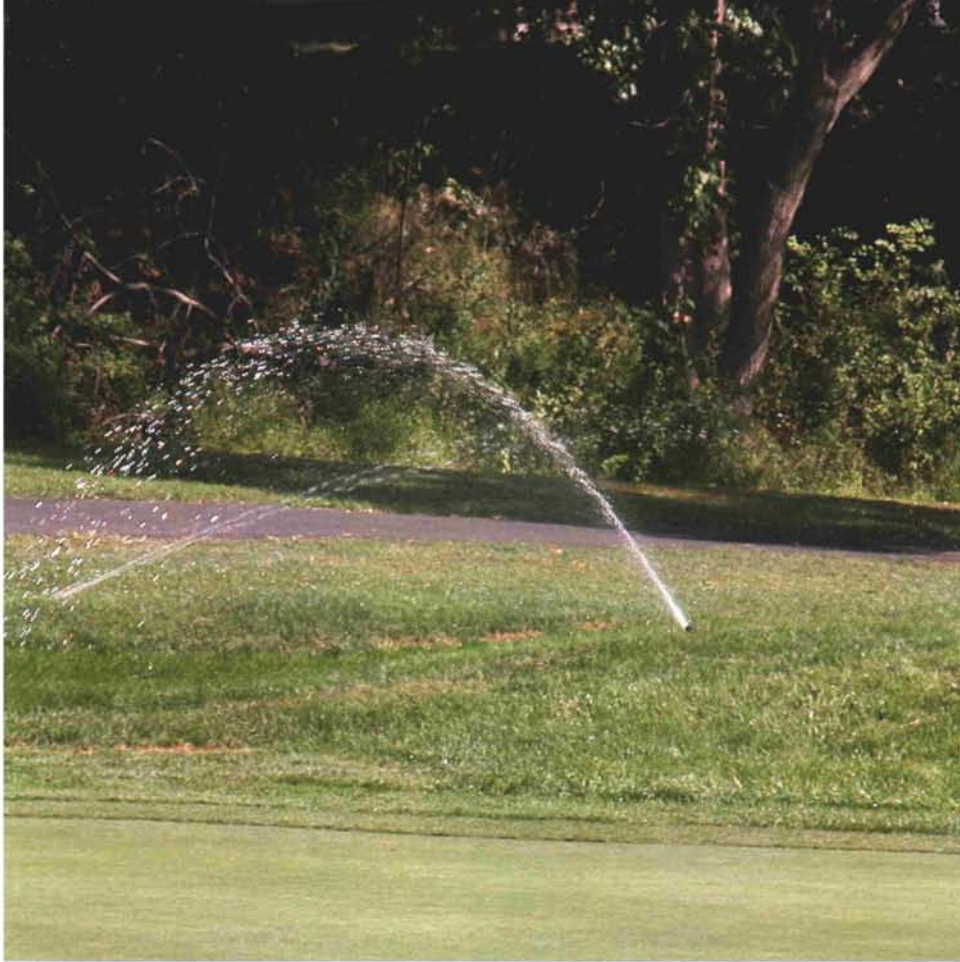
Too many sprinklers on one line spell insufficient pressure and poor coverage.

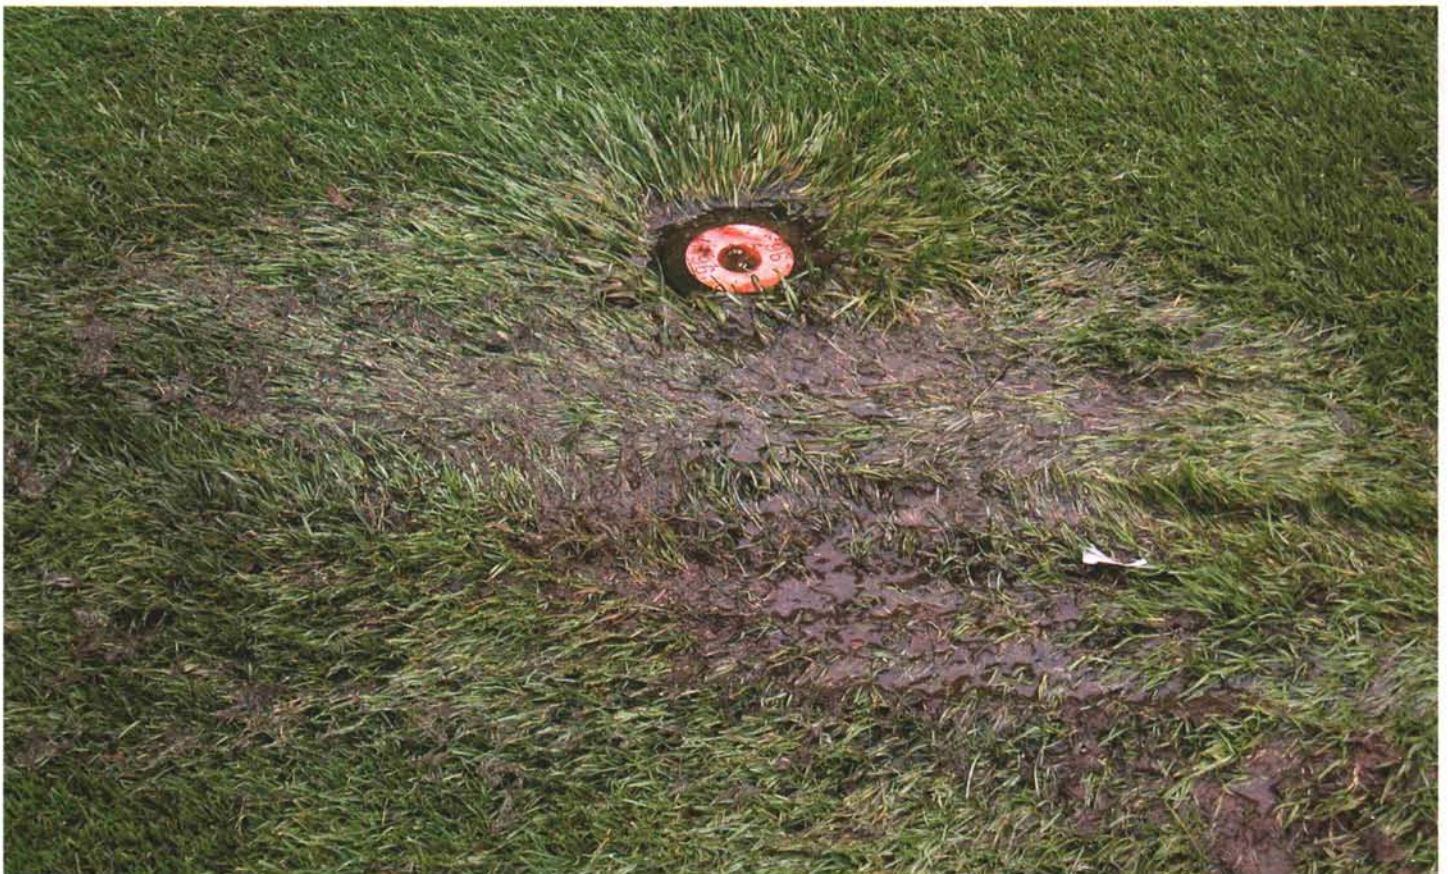
With a zone or block system, the low sprinkler heads in each zone can weep, creating obvious problems.

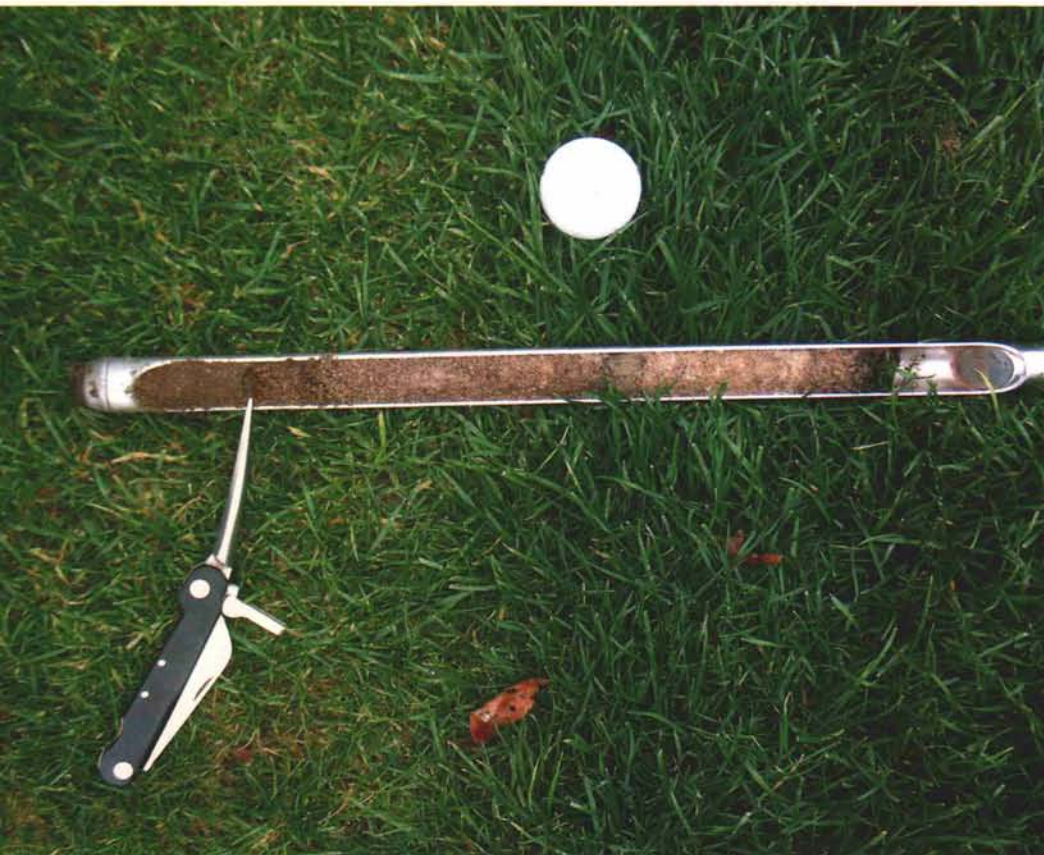
Years of sand being blasted out of bunkers created a droughty, infertile soil that was not capable of supporting healthy turf.

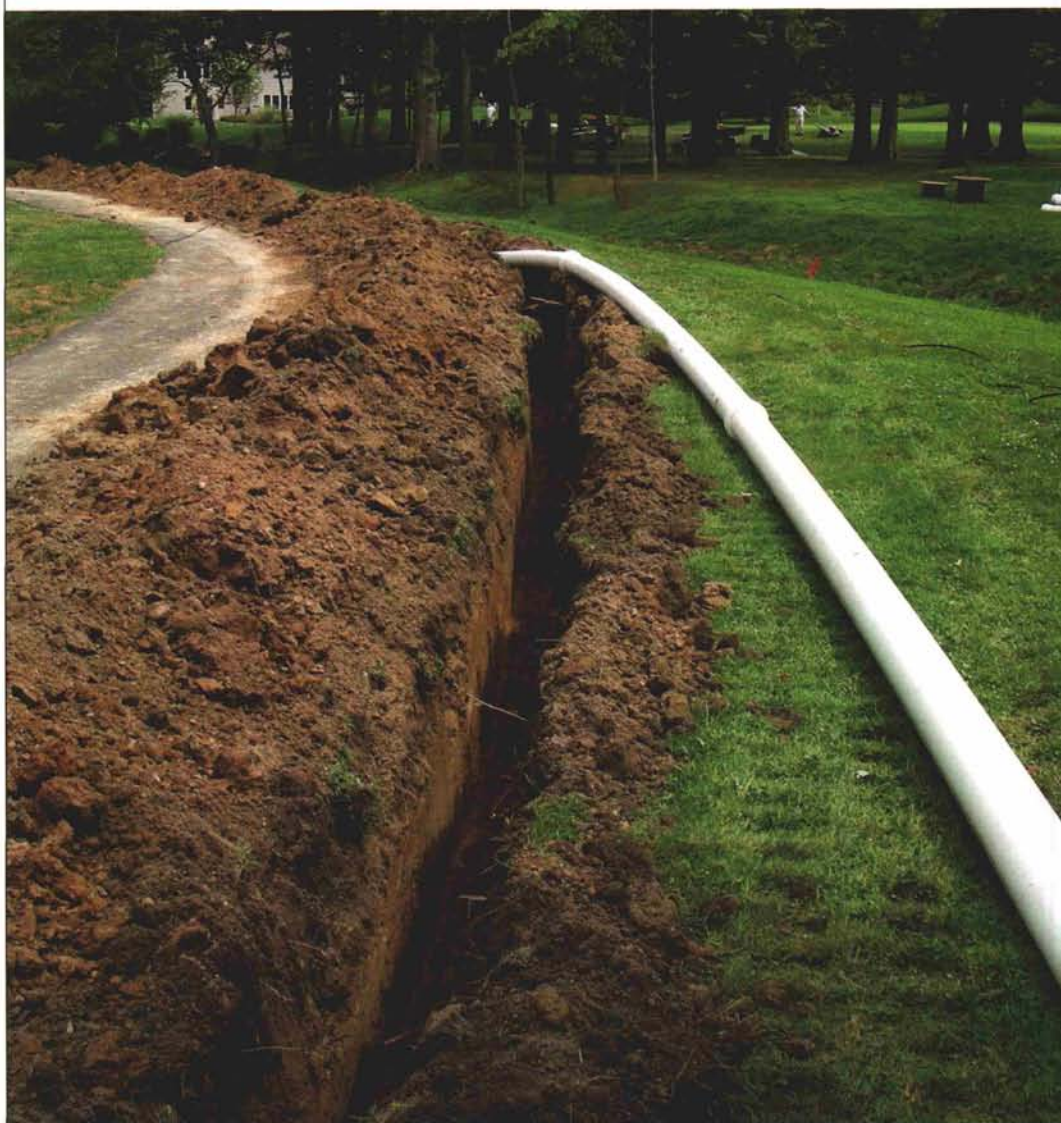
A topnotch new automatic irrigation system with good control and hydraulic flow is an essential tool for effective water management.
